260-IN.-DIA MOTOR PROGRAM

FINAL REPORT
FOR MOTOR 44-SS-4

Contract NAS3-7970

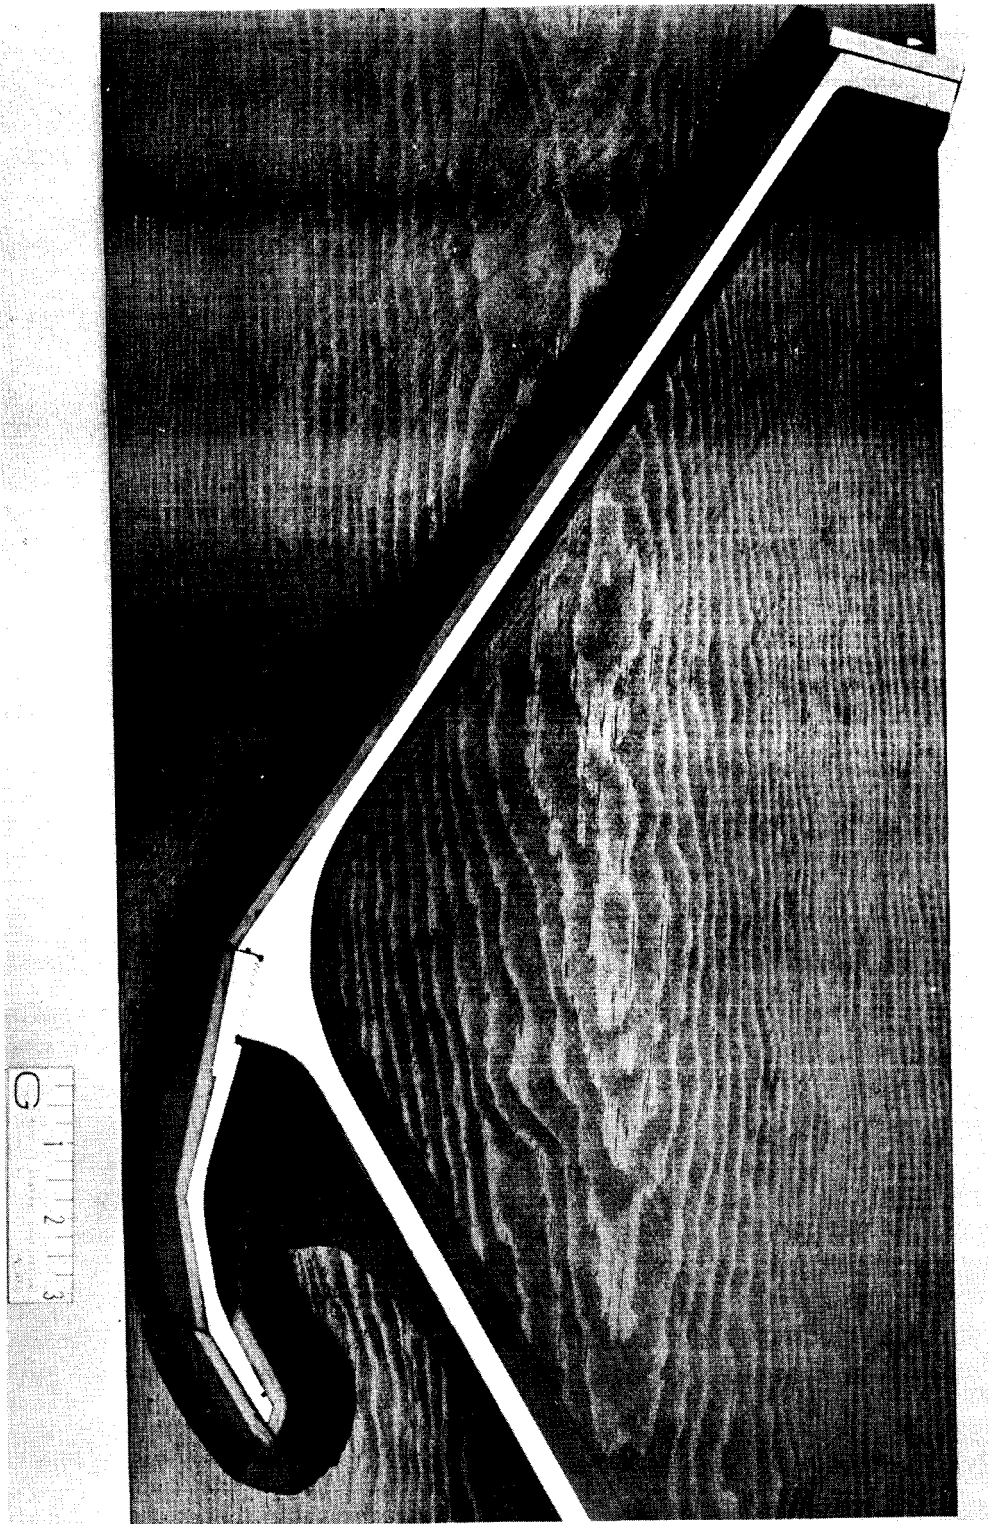
Figure 47

Cross-Section of 44-SS-4 Nozzle at 0° Orientation

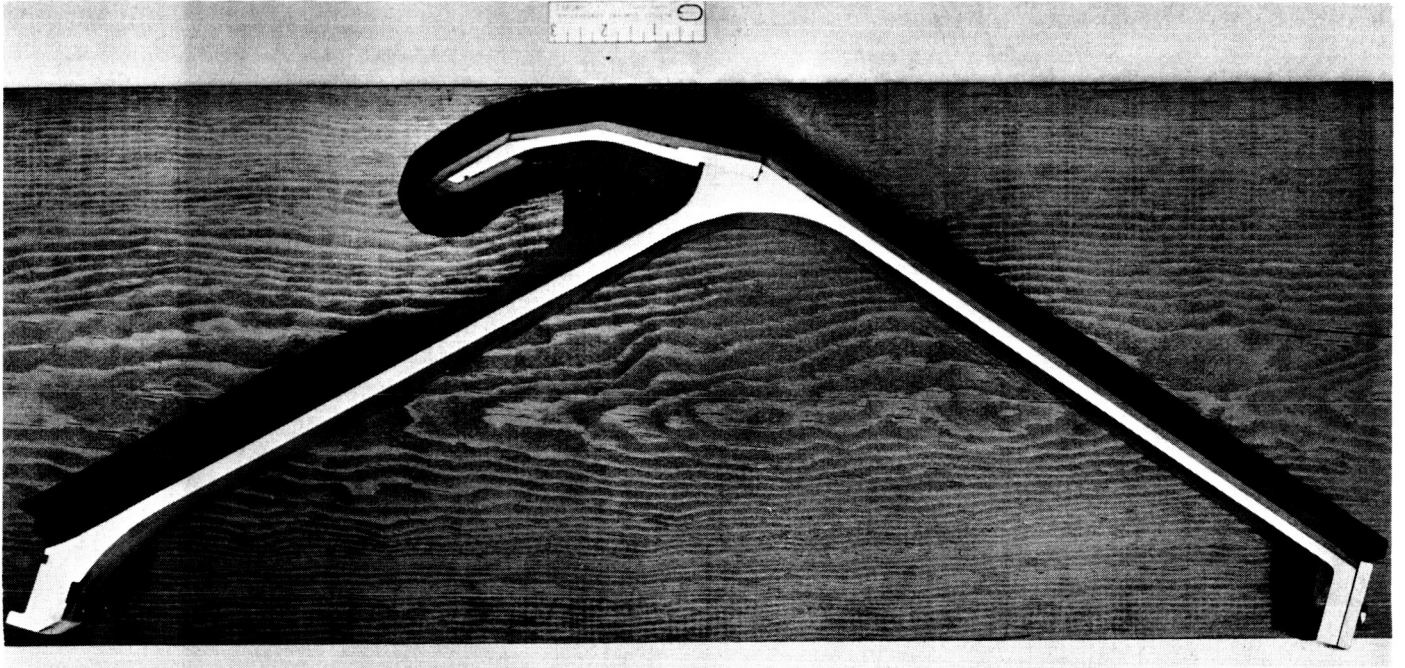
Figure 48

0° Section of 44-SS-4 Nozzle, Posttest View

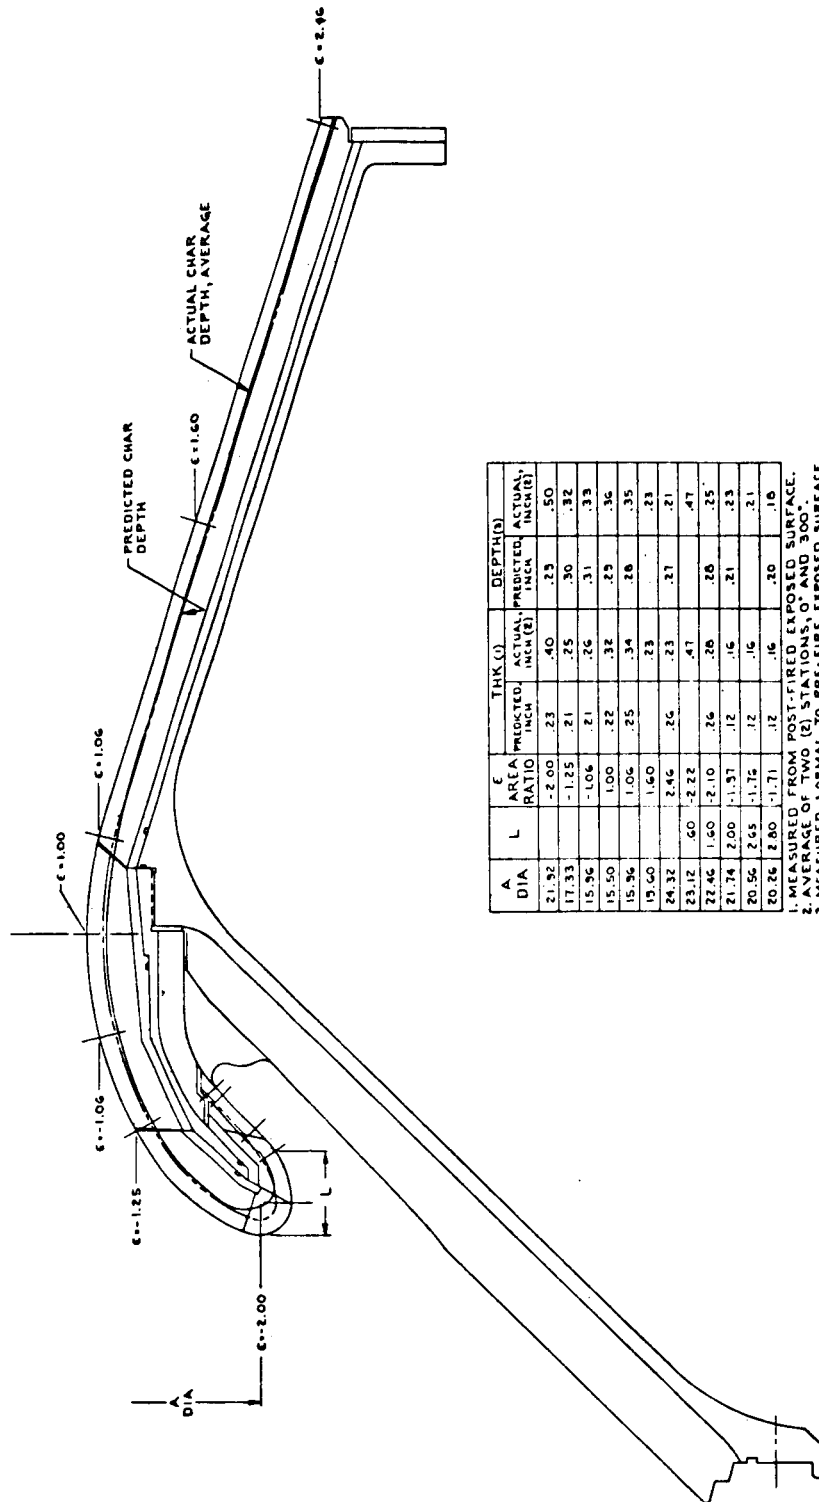
Figure 49

A	DIA	L	E AREA RATIO	THK (1)		DEPTH (2)	
				PREDICTED, INCH	ACTUAL, INCH (2)	PREDICTED, INCH	ACTUAL, INCH (2)
17.32			-2.00	.23	.40	.23	.50
17.33			-1.25	.21	.25	.30	.32
15.96			-1.06	.21	.26	.31	.33
15.50			1.00	.22	.32	.23	.36
15.96			1.06	.25	.34	.28	.35
19.60			1.60	.23	.23	.23	.23
24.32			2.46	.26	.23	.21	.21
23.12	.60	2.22			.47		.47
22.46	1.60	2.10		.26	.26	.26	.25
21.74	2.00	1.37		.12	.16	.21	.23
20.56	2.65	1.75		.12	.16		.21
20.26	2.80	1.71		.12	.16	.20	.18

1. MEASURED FROM POST-FIRE EXPOSED SURFACE.
 2. AVERAGE OF TWO (2) STATIONS, 0° AND 300°.
 3. MEASURED NORMAL TO PRE-FIRE EXPOSED SURFACE.

Nozzle Char Depths

The average char thicknesses measured from these two stations are tabulated in Figure 49. Comparison with predicted char indicated that the measured thicknesses are higher at all stations of the nozzle. The difference was primarily attributed to additional char growth due to heat soak, since the predicted char thickness is based on motor burnout time. Heat transfer analysis of the throat station predicted that char formation continues after motor burnout as shown in Figure 50. The full char thickness including heat soak is predicted to be 0.35 in. and compared closely with the measured char of 0.32 in.

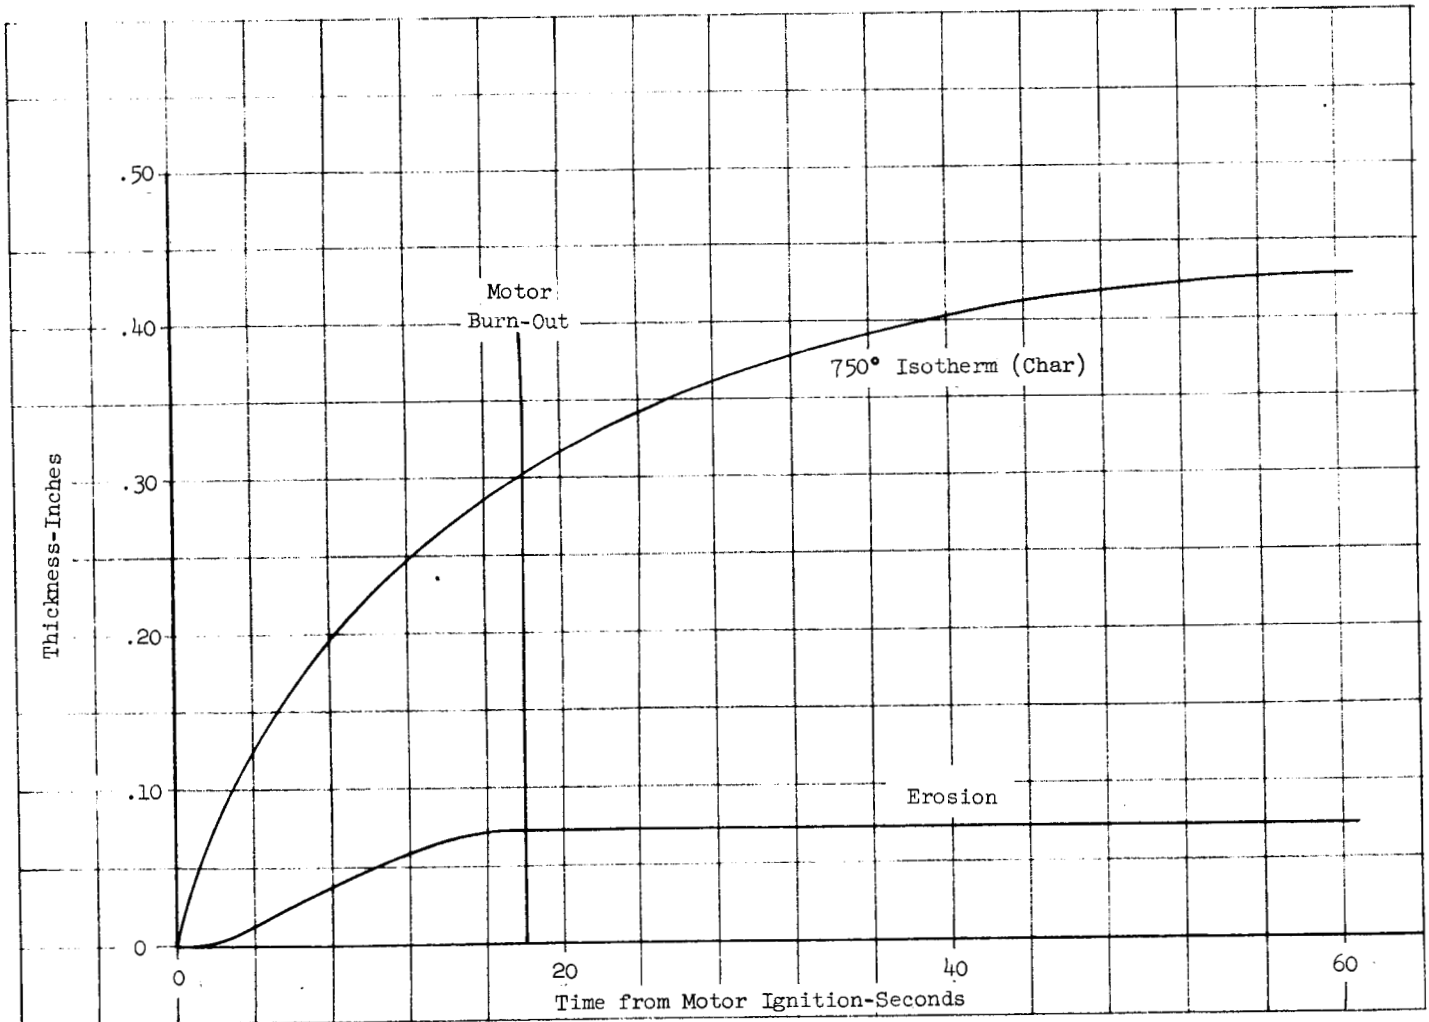
Figure 50

Predicted Erosion and Char Depths at 44-SS-4 Throat Station

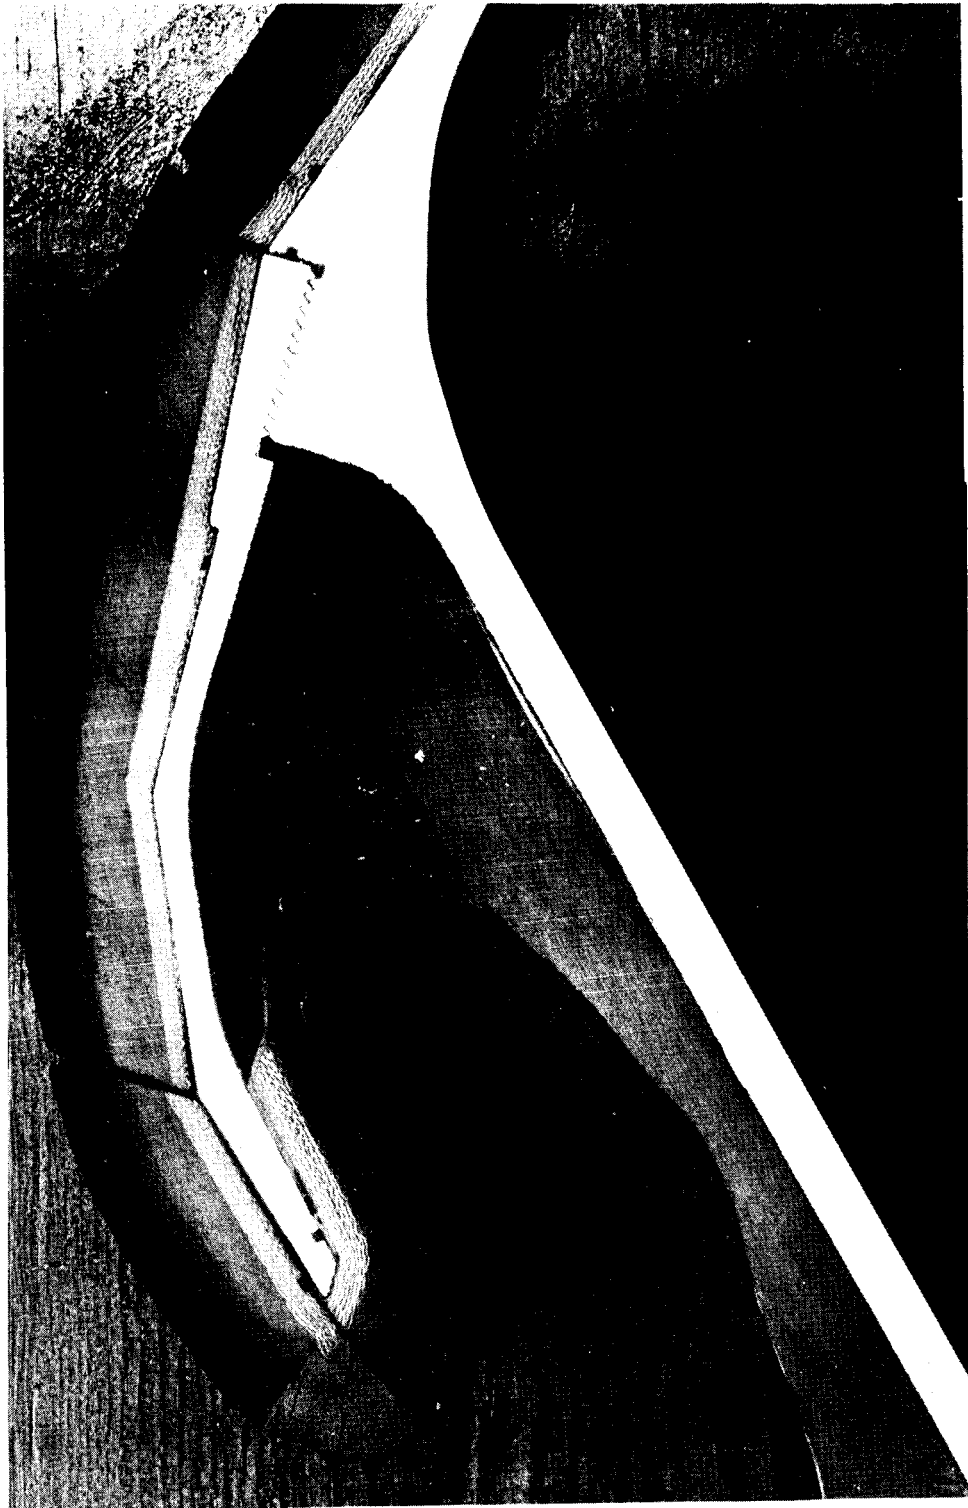
Figure 51

Enlarged View of 0° Cross-Section of 44-SS-4 Nozzle

The laminate orientation in the nozzle components are shown in Figure 51. The orientation of laminates for the nose insert is uniform and is within design requirements. Some reorientation as a result of the debulk and cure cycles was seen in the throat, submerged, and throat extension inserts. The ply orientation in the throat insert was 45-degree to nozzle centerline at the forward end. The orientation gradually changed from 45 to 90-degree to the erosion surface toward the aft end. The ply orientation in the submerged insert has many changes in angles within each ply, which is caused by the complex wrapping surface used during fabrication of this part. The change in orientation for both the throat and submerged inserts was orderly and no significant variation in surface erosion was observed.
